CASE STUDY

HEAT TRANSFER SURFACE LEAK

Bioreactor Heat Transfer Surface Leak

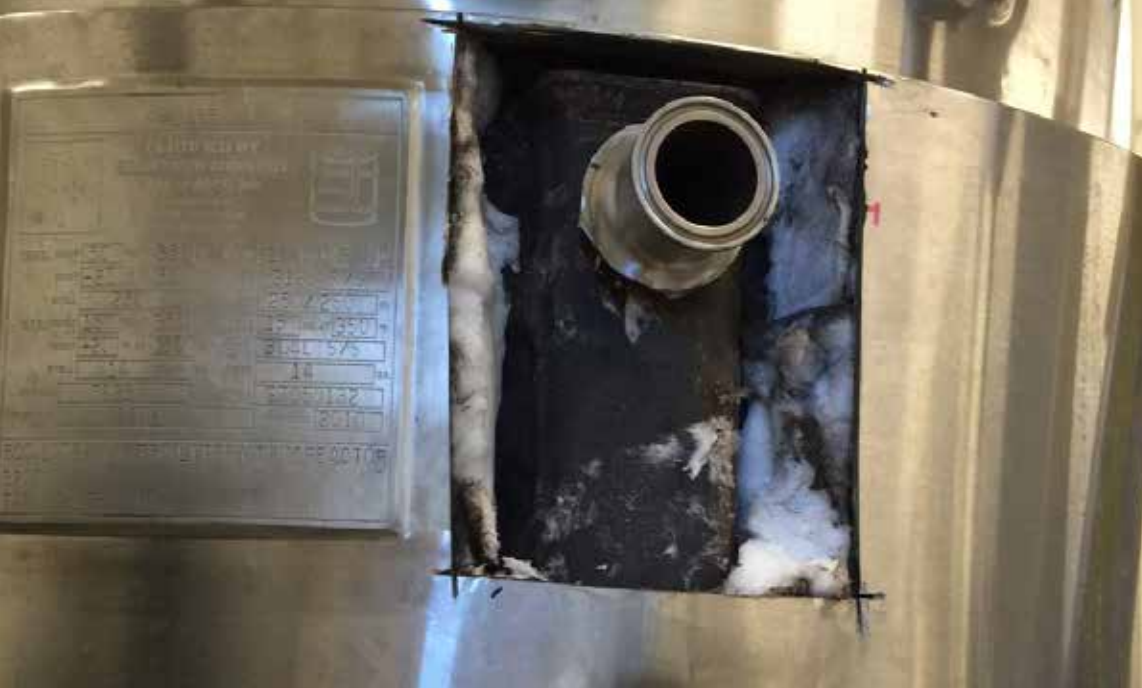
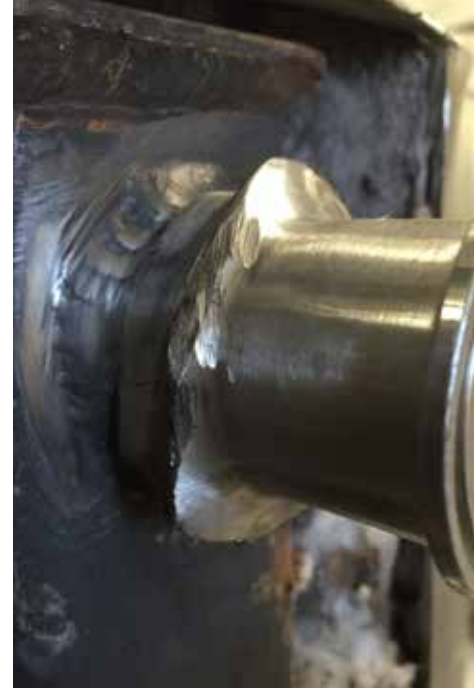
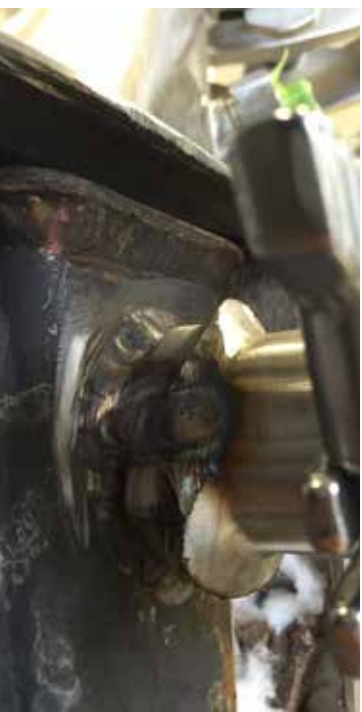
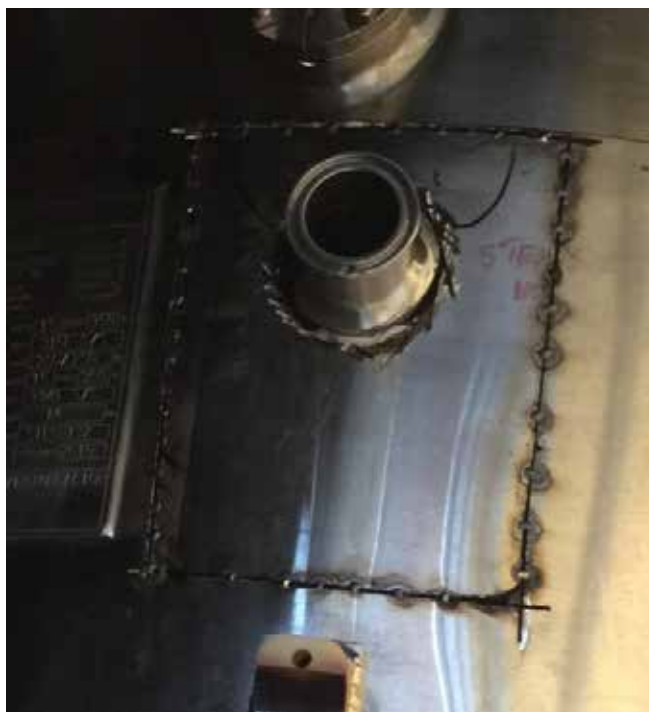
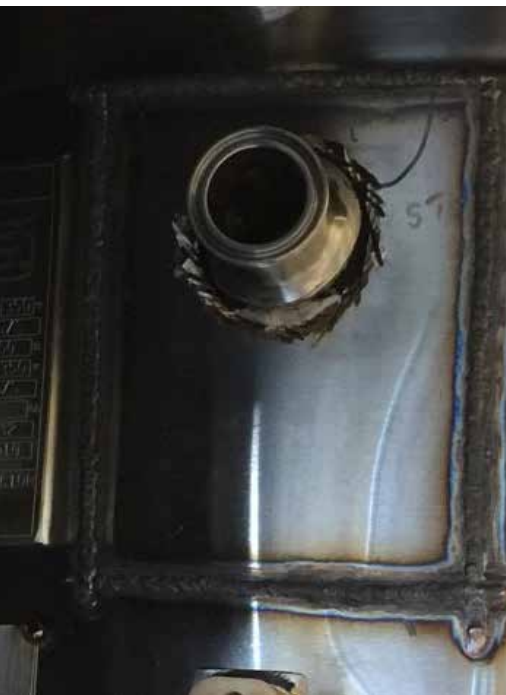
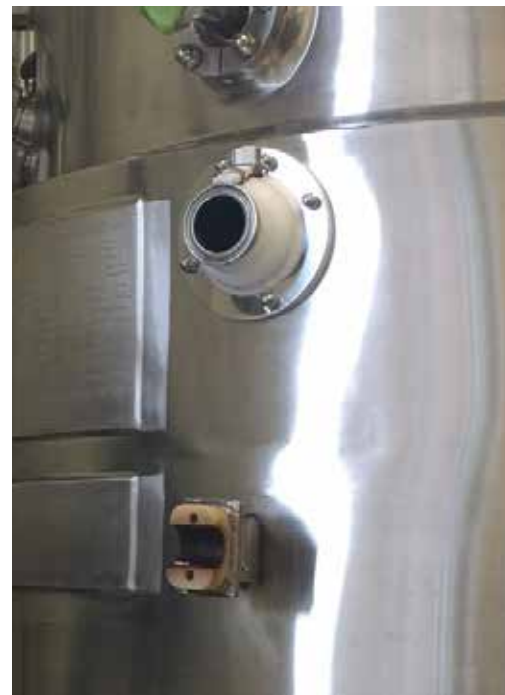
- Located the cracked weld, found on the HTS outlet in the weldment between the HTS pipe and the header
- Inspected the HTS for stress corrosion cracking
- Removed only the sheathing necessary to expose the area of remediation
- Back groove to remove the damaged weld
- Added ASME full penetration weldment
- Hydrotested to satisfy ASME requirements
- Installed flexible boot to absorb movement from thermal shock and to alleviate stress on the connection
- Provided all re-certification and R-stamp documentation

- Identified and repaired a leak caused by thermal shock
- Completed containment of HTS medium
- Reduced stress on the connection from thermal shock
- Vessel exterior, no visual indication of work done
- Vessel back in service within 72 hours
